WIND TUNNEL TESTING OF EDGE METAL

2023 IIBEC INTERNATIONAL CONVENTION & TRADE SHOW

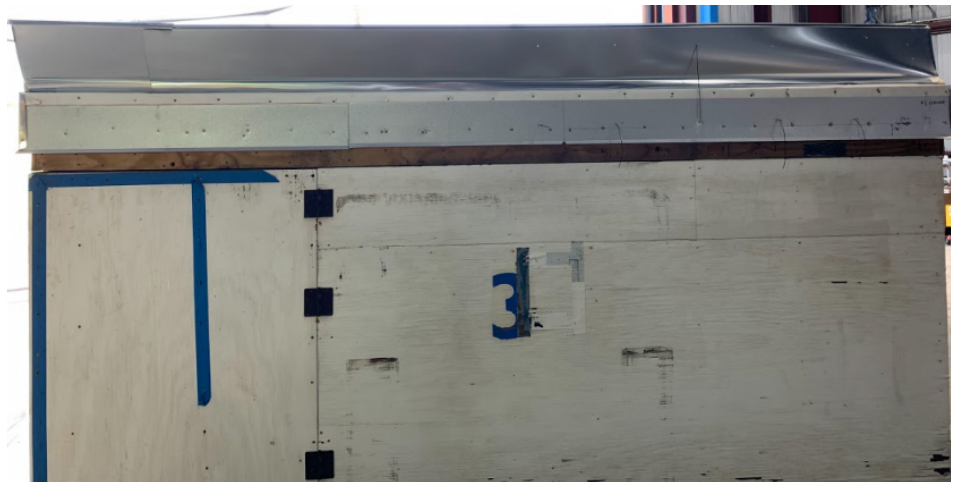
Configuration 1 used cleat 1, the 6 in. (15 cm) cleat. The cleat fastener was located 1¼ in. (4.4 cm) above the break line for the drip edge. Configuration 1 was the only configuration to have a failure before reaching the wind tunnel’s maximum wind speed. During the “low-speed” aerodynamic testing, the fascia released from the cleat nearly the entire length of the test deck, but did not flip up and onto the roof. It was observed that the cleat was likely set too high, and therefore, the engagement of the cleat and the fascia was greatly reduced. The failure assessment testing was initiated without adjustment of the fascia or cleat. During the next wind-speed level, the fascia completely folded back onto the roof its entire length. At that point,

the system was considered to have failed. Observations made of the failure found the cleat was indeed set too high (approximately ¼ in. [.06 cm]) relative to the location of the drip edge portion of the fascia. This reduced the amount of engagement between the cleat and the drip edge (Fig. 10).

Interestingly, configuration 1 was believed to be the most robust of the four installation methods; building-code-required tests for edge metal systems generally confirm this assumption. During this testing, however, this configuration failed at the lowest wind speed due to the misalignment of the cleat fastener. This emphasizes the importance of a well-engaged cleat-drip edge interface.

FIGURE 10: Photo of failure mode of Configuration #1.

- » During the failure where the cleat was set too high, a small (approximately ¼ in. [0.6 cm]) misalignment reduced the amount of engagement between the cleat and the drip edge and significantly reduced the wind speed at failure of the edge metal system.

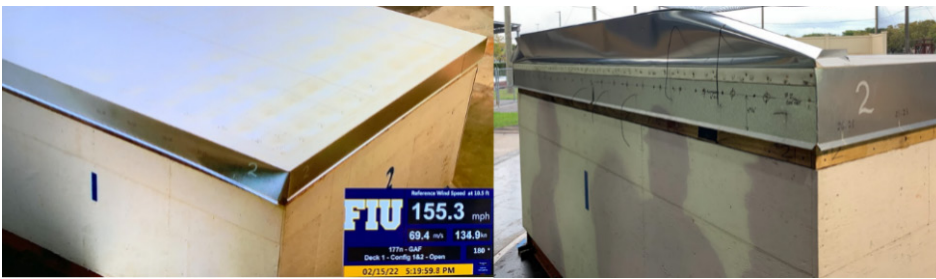
Configuration 2 used cleat 1, the 6 in. (15 cm) cleat. The cleat fastener was located 4½ in. (11 cm) above the break line for the drip edge. A small amount of cleat/drip edge separation with some minimal fluttering of the fascia was seen in the higher wind-speed levels. The small amount of fluttering was located adjacent to the corner where the drip edge receiver was disengaged from the cleat (approx. 6 to 10 in. [15 cm] in length). There was little outward permanent deformation of the fascia and cleat system; the edge metal system appeared to remain able to perform until the point it failed. The failure occurred at approximately 134 mph. The failure was immediate; there was a small amount of flutter at the

FIGURE 11: Photos of failure mode of Configuration #2.

corner, then it was folded up and on top of the roof (**Fig. 11**).

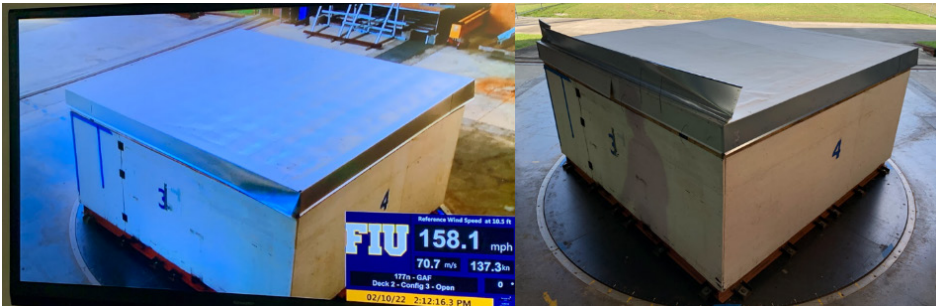
FIGURE 12: Photo of failure mode of Configuration #3.

At approximately 134 mph (215 km/h), the fascia folded up and over the horizontal surface (**Fig. 12**). The drip edge separated from the cleat. The cleat did not have any permanent deformation and remained in place (**Fig. 13**).

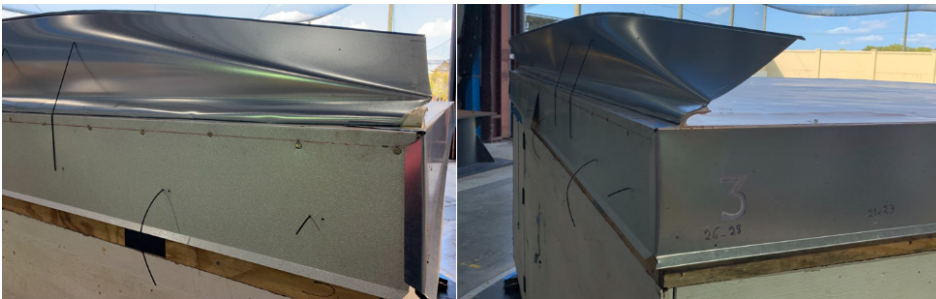
FIGURE 13. Photo of failure mode of Configuration #3 up close.

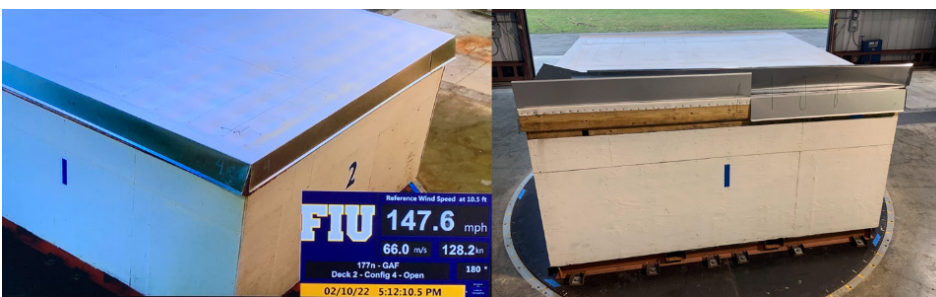
FIGURE 14: Photo of failure mode of Configuration #4.

The portion of the cleat closest to the corner stayed in place while the portion of the cleat farthest from the corner folded upward (**Fig. 14**). Some of the nails pulled out at the far end of the fascia. This seemed to imply that there was a greater pressure at the far end of the “left side” of configuration 4 relative to the other configurations.

- » For configuration 4, the cleat did not entirely disengage from the fascia. Both pieces of metal failed—the metal folded up and over along the length—while still engaged at the drip edge. Failure occurred because the metal yielded; only a few nails pulled out, and only at the far corner.

- » Only configuration 4 had nails pull out of the substrate. A small number of nails fastening the fascia on the horizontal at the furthest end from the corner pulled completely out of the 2x6 wood nailer. No specific reason was determined.
