XYZ Roofing & Siding Company

**The GAF QuickSite Report (the “Report”)** is a bundled report comprised of information from third parties. The information has not been independently verified by GAF. Purchaser agrees that use of information obtained from the Report is at Purchaser’s own risk, and that GAF will not be held liable for any errors or omissions contained in the Report. It is Purchaser’s responsibility to independently verify information contained in the Report before relying on it. **GAF provides the Report on an “as is” basis and expressly disclaims any and all warranties with respect to such Report, express and implied, including, but not limited to, any warranties against infringement, of accuracy, reliability, completeness, title, merchantability, fitness for a particular purpose, or any other warranty, condition, guarantee or representation. In no event shall GAF be liable for any damages whatsoever, whether direct, indirect, consequential, incidental or special, or any claim for attorney’s fees arising out of the Report, including, but not limited to, Purchaser’s use of the Report.** Commercial resale of the Report is strictly prohibited.

**REPORT #:** 361464

# 1

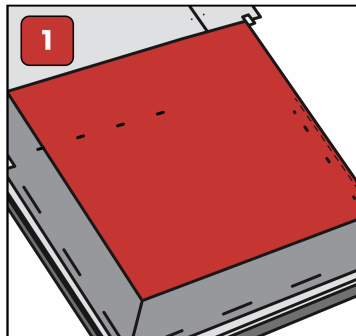
**R905.1.2 ICE BARRIERS.**

In areas where there has been a history of ice forming along the eaves causing a backup of water as designated in Table R301.2, an ice barrier shall be installed for asphalt shingles, metal roof shingles, mineral-surfaced roll roofing, slate and slate-type shingles, wood shingles and wood shakes. The ice barrier shall consist of not fewer than two layers of underlayment cemented together, or a self-adhering polymer-modified bitumen sheet shall be used in place of normal underlayment and extend from the lowest edges of all roof surfaces to a point not less than 24 inches (610 mm) inside the exterior wall line of the building. On roofs with slope equal to or greater than 8 units vertical in 12 units horizontal (67-percent slope), the ice barrier shall also be applied not less than 36 inches (914 mm) measured along the roof slope from the eave edge of the building.

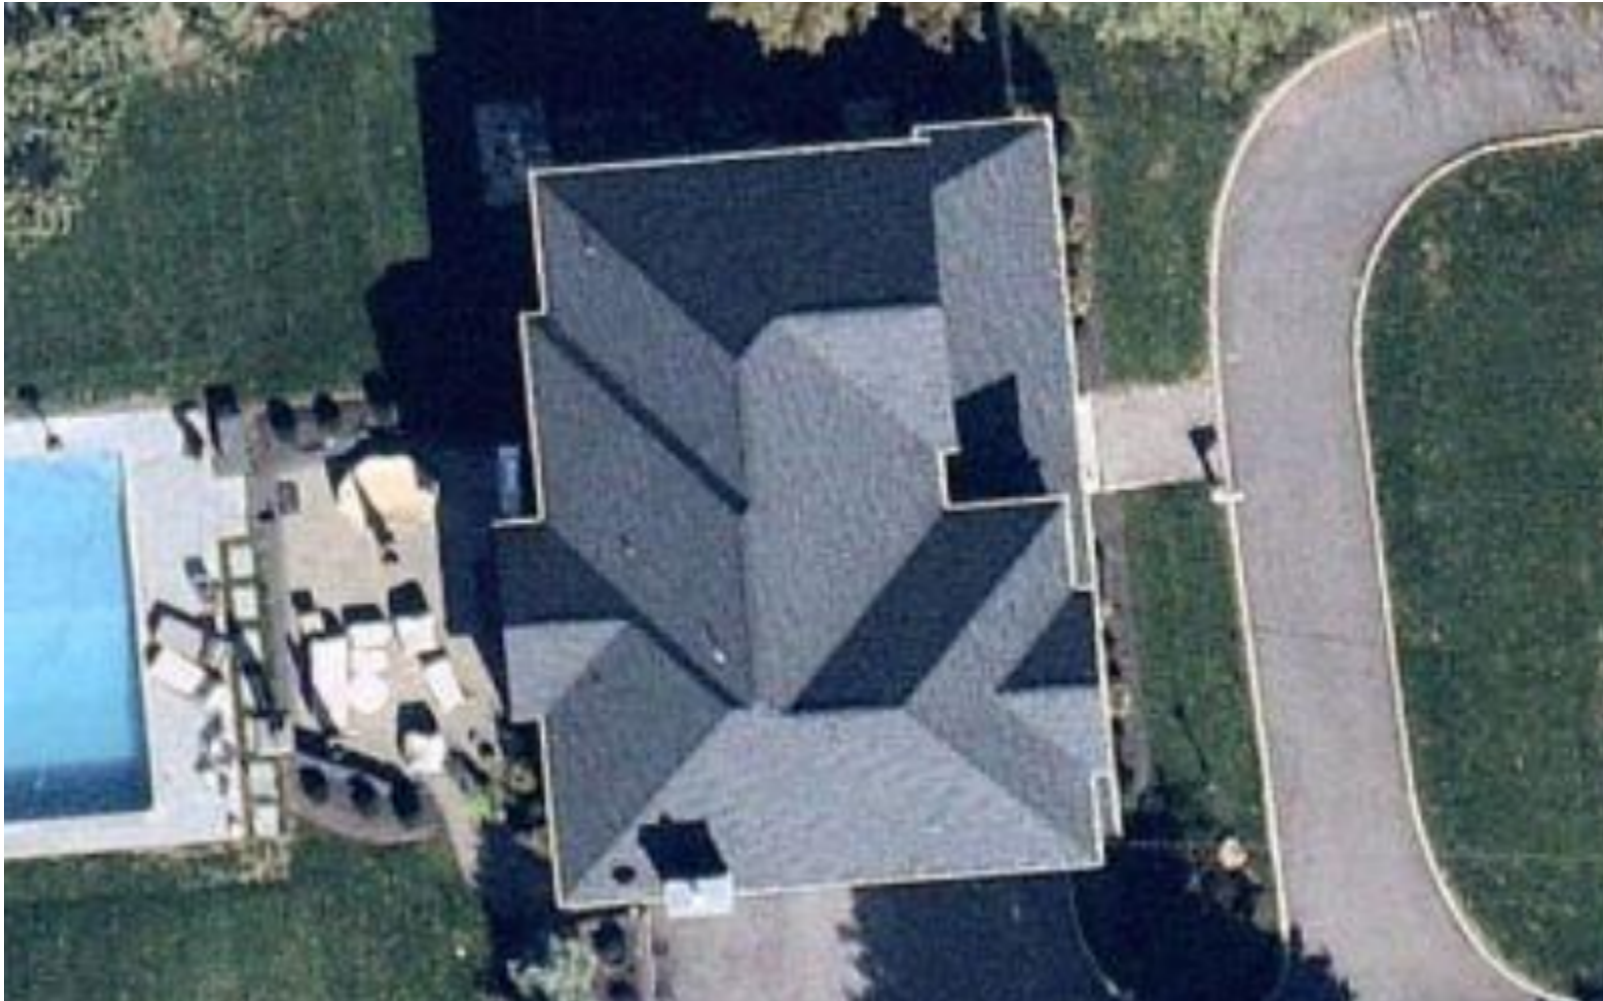
Building: 1  
Roof Footprint: 2,866 ft<sup>2</sup>  
Shape: Hip (100% Confidence)  
Material: Asphalt Shingle (98% Confidence)

Structural Damage	None
		Missing Shingles	None
		Tarp	None
		Rust	None
		Patching	None
		Ponding	None
		Debris	None
		Overhang	None

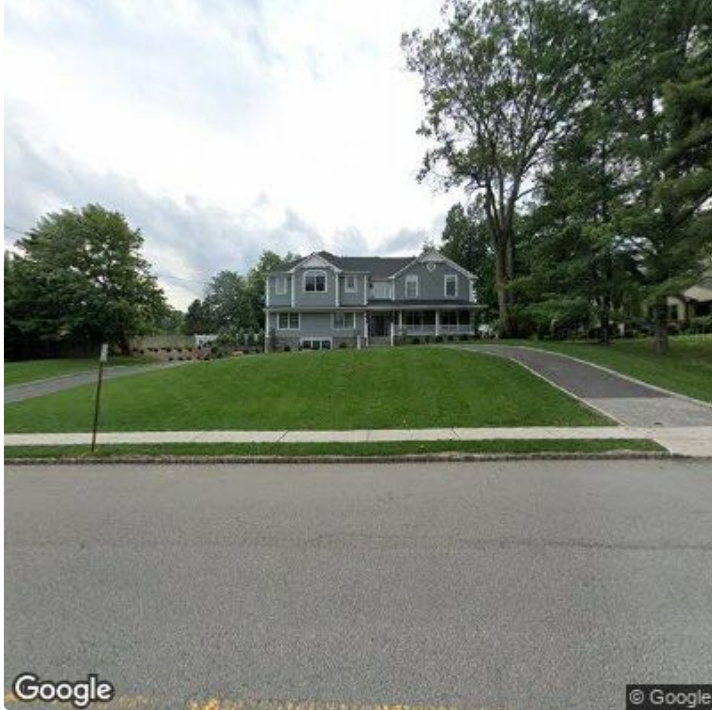
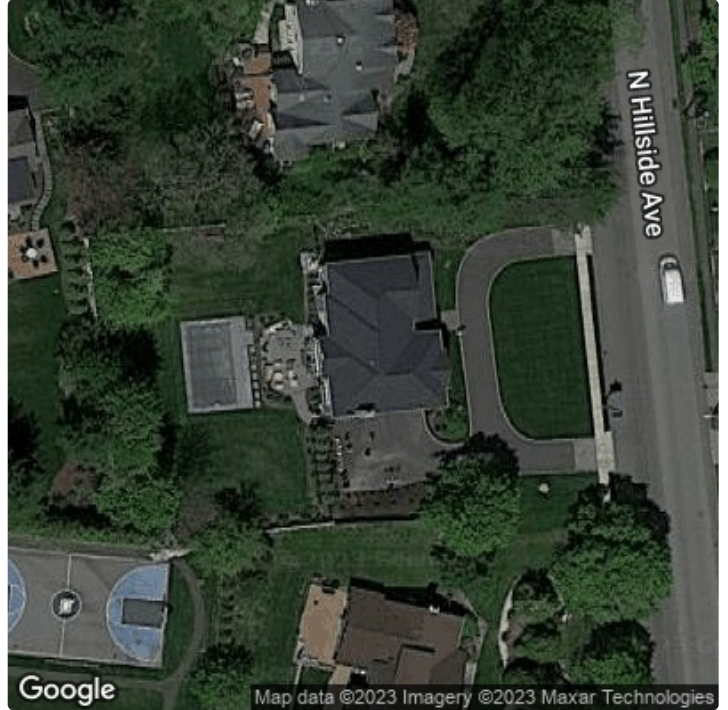
**Living Area** 2,050 sqft  
**Garage** (0)  
**Bedrooms** 0  
**Bathrooms** 0  
**Roof Material** Shingle ©  
**Roof Shape** Hip ©  
**Roof Condition** Good ©  
**Roof Solar** False ©

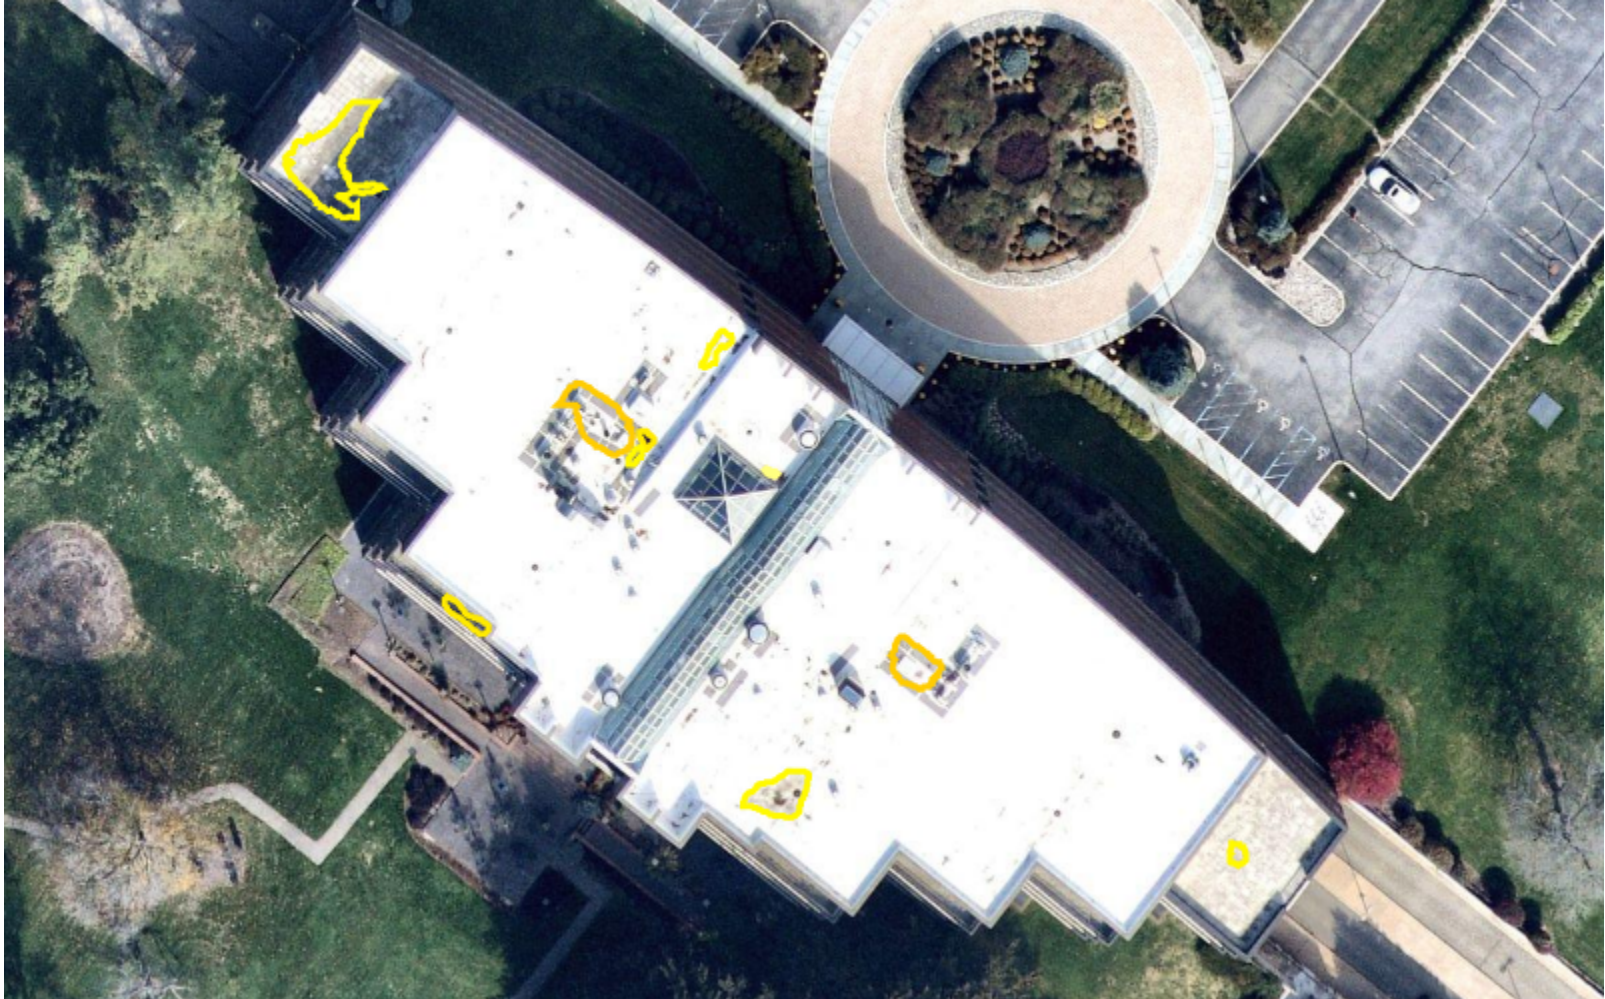
Building: 1  
 Roof Footprint: 30,506 ft<sup>2</sup>  
 Shape: Flat (100% Confidence)  
 Material: Roof Coating (76% Confidence)

Structural Damage	None
		Tarp	None
		Rust	None
		Patching	Moderate (1%, 328 ft <sup>2</sup> )
		Ponding	Moderate (0%, 51 ft <sup>2</sup> )
		Staining	Minor (2%, 581 ft <sup>2</sup> )
		Debris	Moderate (0%, 4 ft <sup>2</sup> )
		Overhang	None
