# Physical Testing for Wind Resistance of Retrofit Single-Ply Roof Systems Over Structural Metal Panel Roof Systems

**IIBEC 2020 Virtual International  
Convention and Trade Show  
June 12-14, 2020**

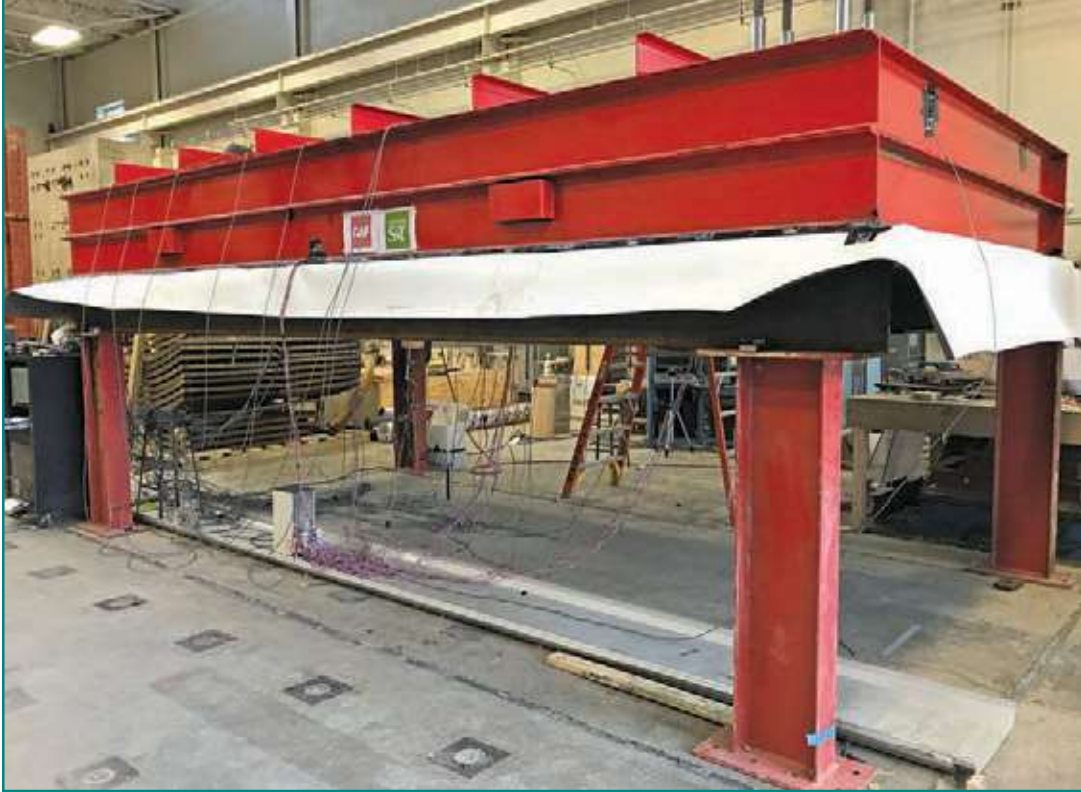
**Figure 1 – The as-built chamber for Test #3.**

data collection. *Figure 1* shows the as-built E1592 physical testing chamber; it is supported by four columns.

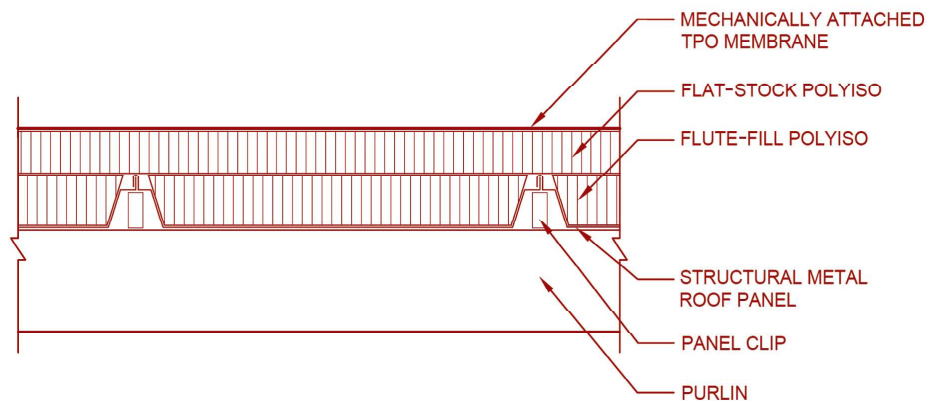
**Figure 2 – Cross section of the RSPRS over a structural metal panel roof system.**

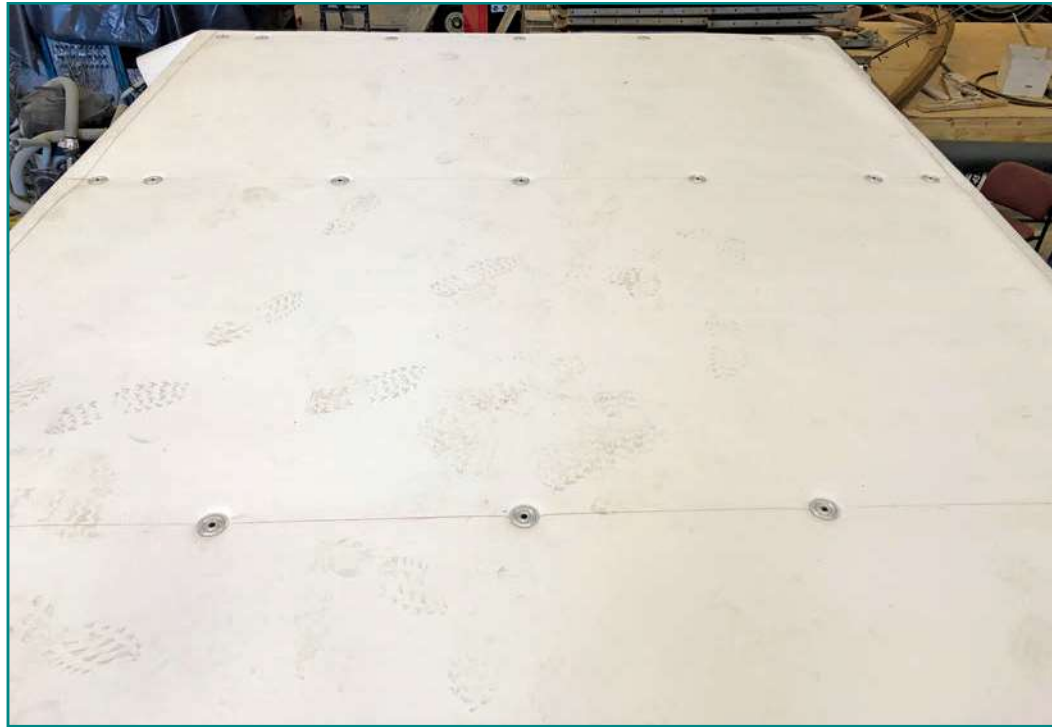
*Figure 3 – The installed TPO for Test #2.*

A 60-mil TPO membrane was installed over the insulation for each test. Details of the four distinct TPO installations are provided in the next section. *Figure 3* shows the installed TPO for Test #2.

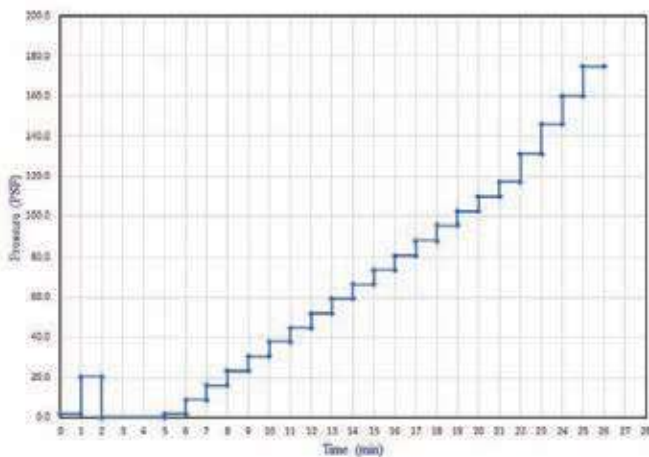
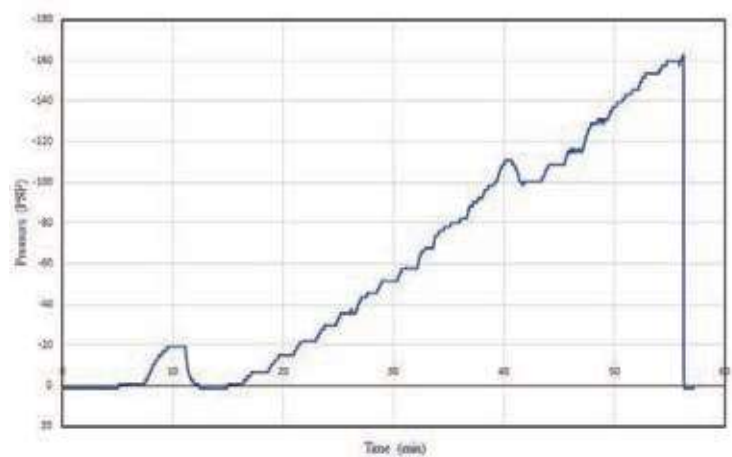
*Figure 4 – The loading scheme defined by ASTM E1592 and the actual loading scheme for Test #1.*

Failure was either membrane rupture or fastener failure. This will be discussed in detail later in the paper. *Figure 4* shows the loading scheme defined by ASTM

E1592 used for testing and the actual loading scheme from Test #1.

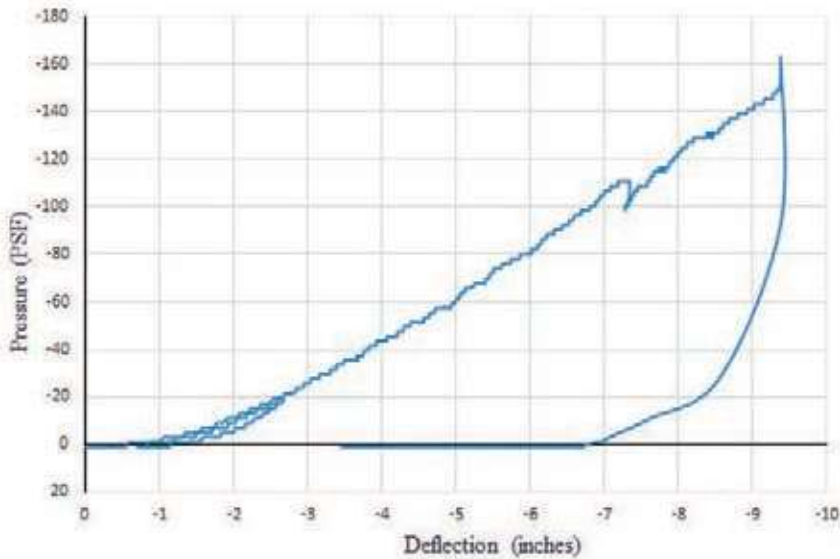
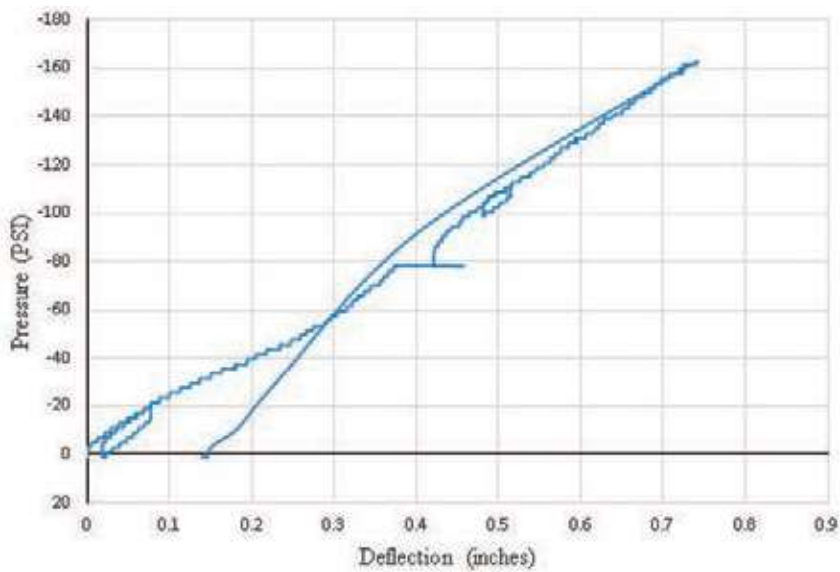
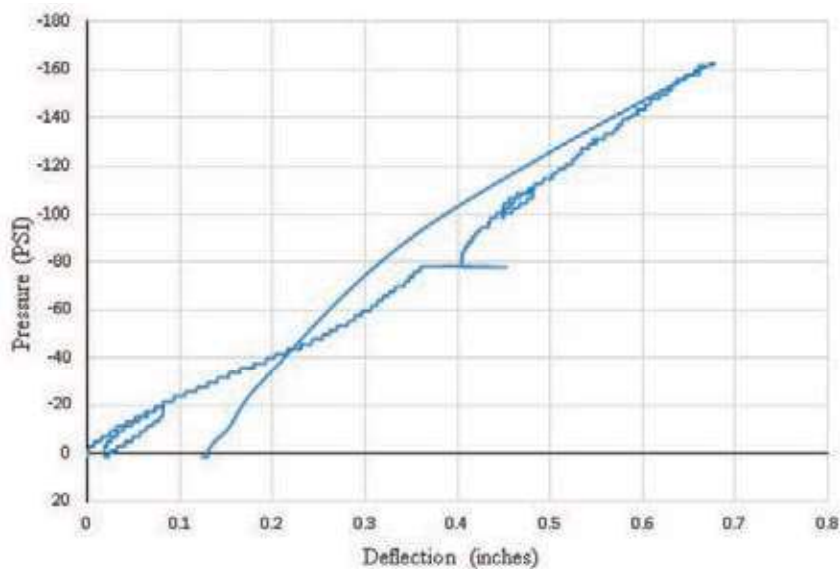
**Figure 5 – Applied pressure versus deflection for Test # 1: (a) membrane at mid-span between two rows of fasteners, (b) the screw for the metal panel clip, and (c) membrane fastener.**

Figure 5 provides examples of the data collected during each test. These show the mid-span deflection of the membrane, the deflection of the screw for the metal panel clip, and the deflection of the membrane fastener at the middle purlin. The examples are from Test #1.

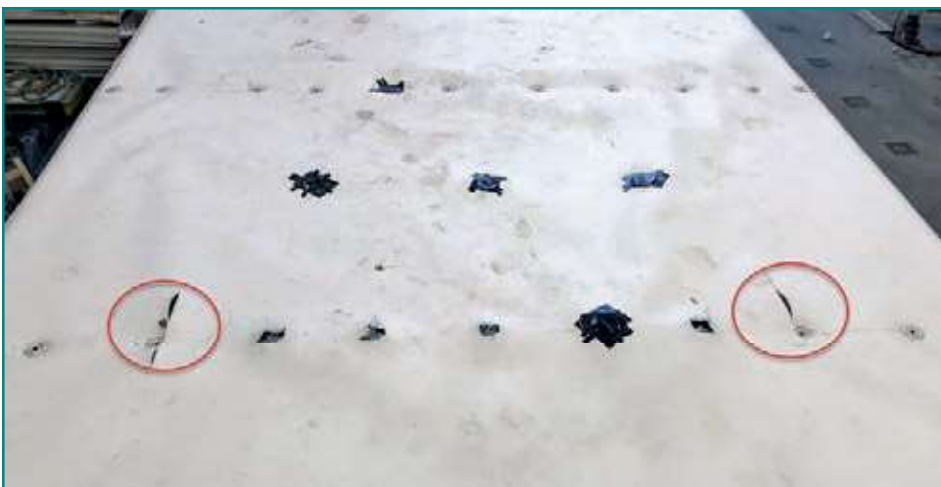
**Figure 6 – The outcome of Test #1. The membrane ruptured at the center row of fasteners. The outer two fastener locations where the membrane tore in an “L” shape are identified by red circles.**

simultaneously at seven fastener locations in the center purlin/row of fasteners. The system successfully completed 160.1 psf and then failed as the pressure was being increased to 174.5 psf. The membrane pulled over the five center fastener plate locations in an essentially circular pattern along the outer edges of the fastener plates. The outer two failure locations resulted in L-shaped tearing of the membrane, which was attributed to the boundary conditions of the test chamber. The fastener plates were deformed upward. There were many locations of permanent upward membrane deformation.

Figure 6 shows the outcome of Test #1.

The permanent upward membrane deformation was evident along the edges of the rows of fasteners, as can be seen in the upper row of fasteners in Figure 6. There was very little permanent upward membrane deformation at the centerline between fasteners within a row. This pattern of deformation leads to the belief that the load within the membrane is being transferred from fastener row to fastener row, and not significantly from fastener to fastener within a row. See Subsection “Test #3” for additional discussion.

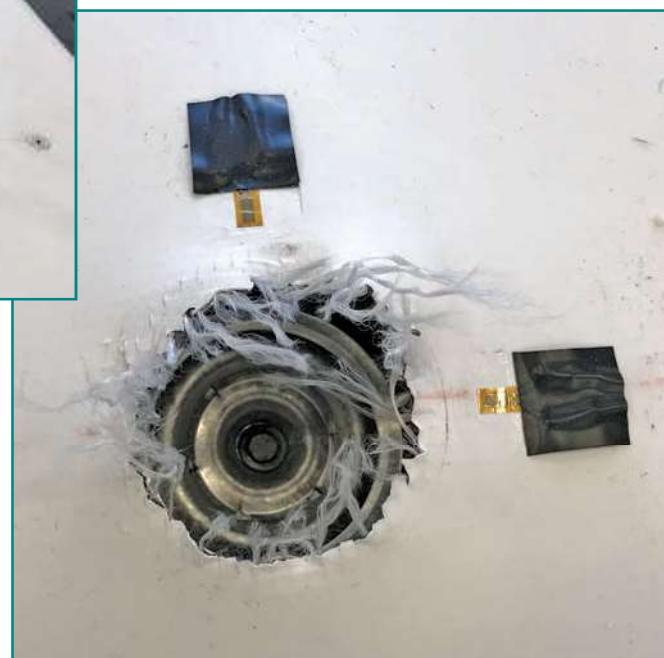
**Figure 7 – Membrane ruptures at the fastener plate locations for Test #2.**

The fastening pattern for Test #2 was 5-ft. o.c. fastener rows and 24-in. fastener spacing within the row. Test #2 failed when the membrane ruptured simultaneously at the three central fastener locations in the southern quarter-point row of fasteners. The system successfully completed 116.9 psf and then failed as the pressure was being increased to 124.1 psf. The membrane pulled over the three center fastener plate locations within the row. The center rupture was circular at the fastener plate. The outer two ruptures were D-shaped; the straight-line edges were attributed to the boundary conditions of the test chamber. Figure 7 shows the rupture at the center fastener plate from Test #2.

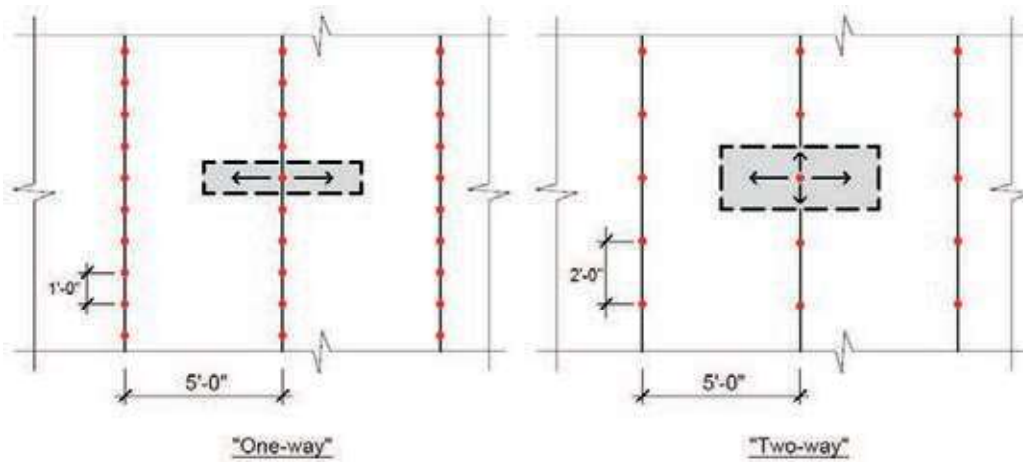
**Figure 8 – Graphical representation of one-way and two-way loading.**

This led to the assumption that the ultimate load for Test #2 would be one-half of that from Test #1, or 81.4 psf. However, the ultimate load was 119.5 psf, which is approximately 73% of that from Test #1. This is believed to indicate that the membrane transitioned from one-way loading to two-way loading, as shown in Figure 8.

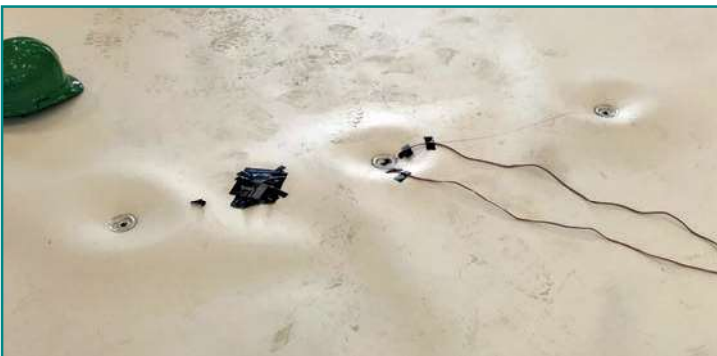
**Figure 9 – Circular permanent upward membrane deformation due to two-directional loading in Test #2.**

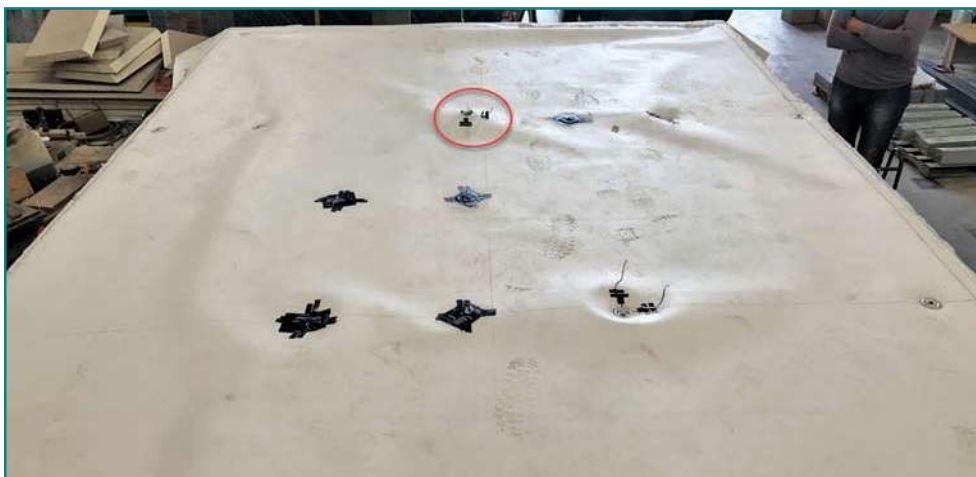
**Figure 10 – The failure location for Test #3, noted by the red circle.**

The fastening pattern for Test #3 was 5-ft. o.c. fastener rows and 36-in. fastener spacing within the row; fasteners were staggered row to row. Test #3 failed when the membrane ruptured at a single fastener location in the southern quarter-point row of fasteners. The system successfully completed 59.3 psf and then failed as the pressure was being increased to 66.5 psf. The membrane pulled over the centermost fastener plate within the row, as shown in Figure 10.

Similar to Test #2, there was circular upward permanent membrane deformation at fastener locations for Test #3 as shown in *Figure 10*. This shows that the membrane is being loaded in the MD and XMD. This is due to the relatively wide spacing of the fasteners (2 ft. and 3 ft.) relative to Test #1, which had 1-ft. spacing of fasteners within a row.

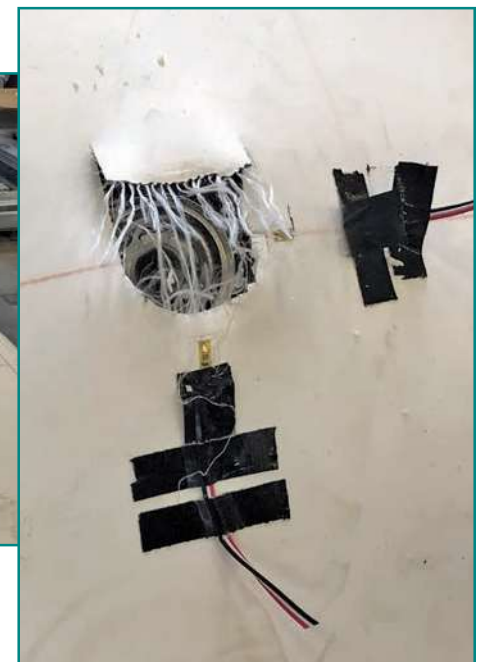
**Figure 11 – The failure location for Test #3.**

Figure 11 shows a close-up of the failure location for Test #3. The failure was

D-shaped, similar to failure locations in Test #2. The flat edge was on the boundary edge of the test roofs; the rounded edge was towards the center of the test roof.

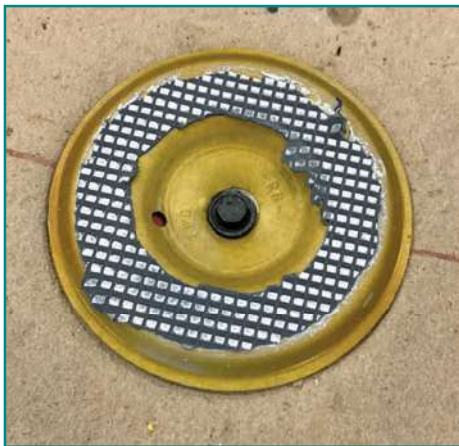
**Figure 13 – The top of an induction-welded fastener plate showing membrane delamination (cap to core separation).**

The above-membrane fastener (e.g., an in-seam fastener) is 2-3/8 inches in diameter. An induction-welded fastener plate is 3 inches in diameter and is constructed such that a "ring" adheres to the membrane, not the entire fastener plate. *Figure 13* shows this explicitly.

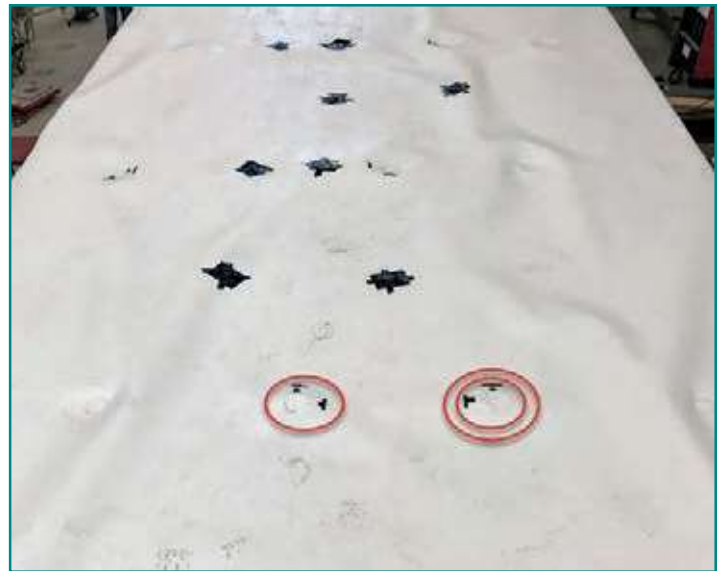
**Figure 12 – The two failure locations for Test #4. The double red circle is where the fastener plate pulled over the fastener; the single red circle is the location of the membrane separation at the reinforcement layer.**

The fastening pattern for Test #4 was 5-ft. o.c. fastener rows and 24-in. fastener spacing within the row; fasteners were staggered row to row and induction welded. Test #4 failed in two locations when one fastener plate pulled over the fastener head and the membrane separated at the reinforcement layer at the adjacent welded fastener plate. The system successfully completed 59.3 psf and then failed as the pressure was being increased to 66.5 psf. The failures occurred in the southern quarter-point row of fasteners. *Figure 12* shows the failure locations for Test #4.

It was difficult to determine from visual examination which occurred first: the fastener plate pulling over the fastener head or the delamination of the membrane to the fastener plate. However, based on the loud noise that occurred at failure, it is believed that the fastener plate pulled over the fastener first and then load was immediately transferred to the adjacent fastener plate, causing the delamination.

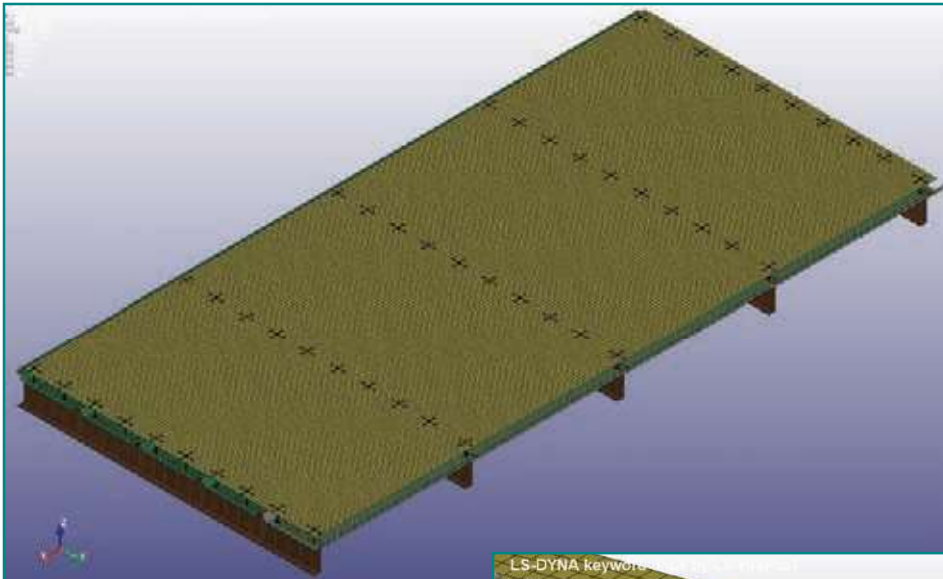
Figure 14 – Finite element modeling of RSPRS using LS-DYNA®.

Finite element (FE) modeling was carried out using LS-DYNA® software to investigate the behavior of the RSPRSs. The system was modeled using solid elements to be able to simulate the actual behavior of the roof system. Each RSPRS model was subjected to uniform negative pressure to simulate the wind uplift pressure. The FE models have the same dimensions and configuration as those of the tested RSPRSs. Different material models were selected for the steel members and the single-ply membrane to simulate accurate behavior of the roof. Detailed contact modeling between the fasteners and the pur-

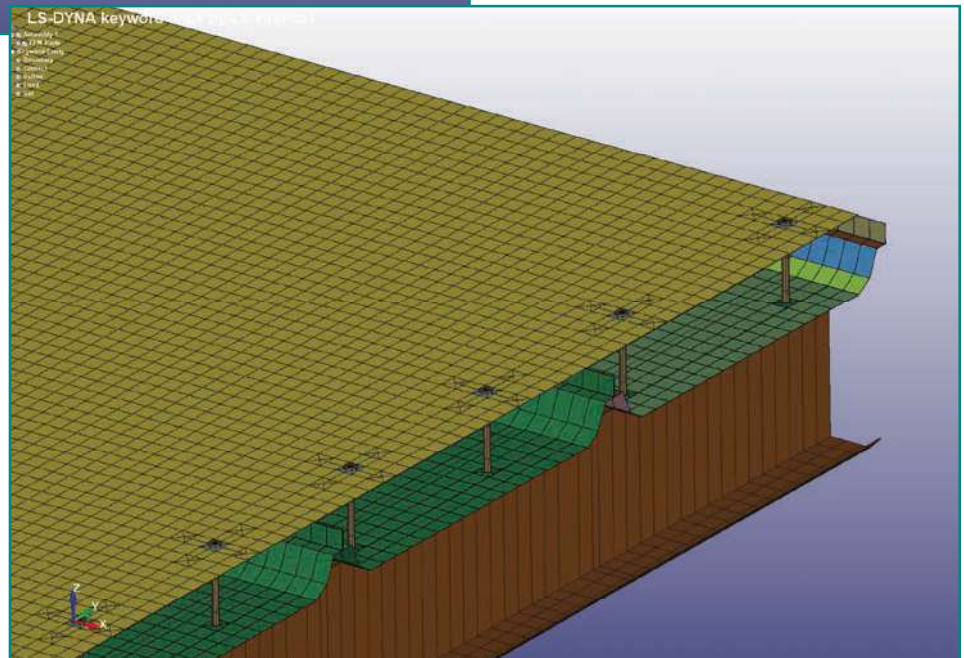
Figure 15 – Different element simulation of the RSPRS.

lins, as well as between the fasteners and single-ply membrane, is vital in this study to ensure accurate representation of the friction between different elements. Two types of contact were used in the modeling process: nodes-to-surface and surface-to-surface. Figure 14 shows the geometry of the simulated roof system in LS-DYNA. The connection between the metal panels and the purlins was also simulated to account for the deformation that occurred between the panels and the purlins. Figure 15 shows the configuration of the different elements considered in the FE model.

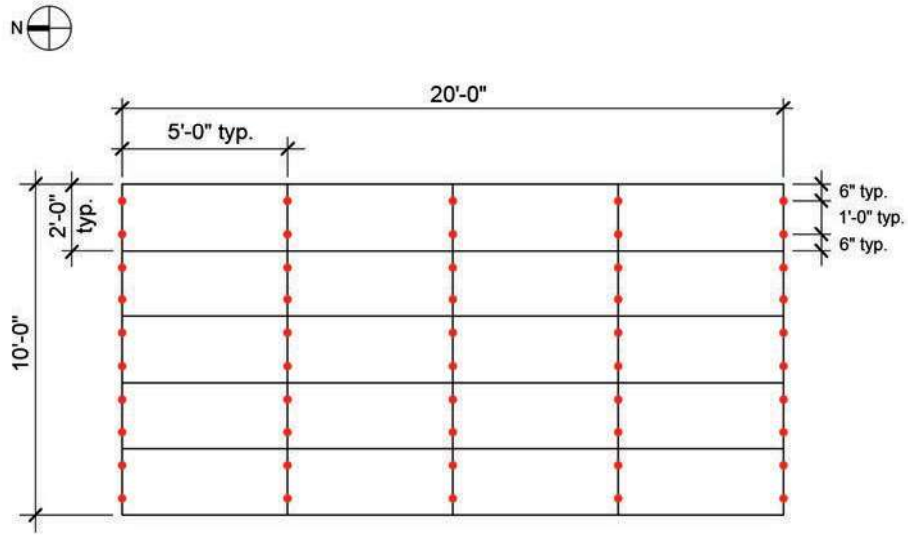
### Test #1: Fastener Pattern

Test #1 Fastener Pattern  
5'-0" o.c.; 12" in-row spacing

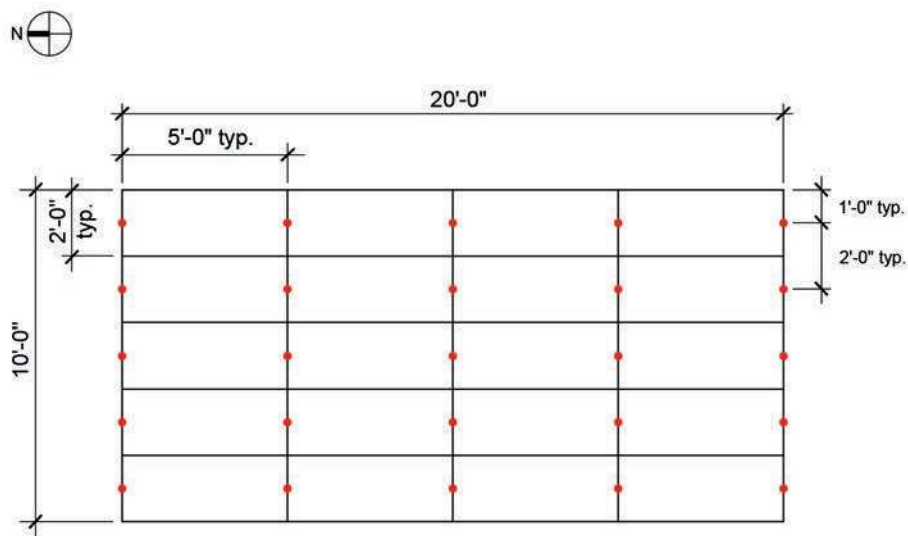
### Test #2: Fastener Pattern

Test #2 Fastener Pattern  
5'-0" o.c.; 24" in-row spacing
