# Designing for the impacts of Very Severe Hail

By Jennifer Keegan, AAIA, GAF

PUBLISHED: AUGUST 2, 2022

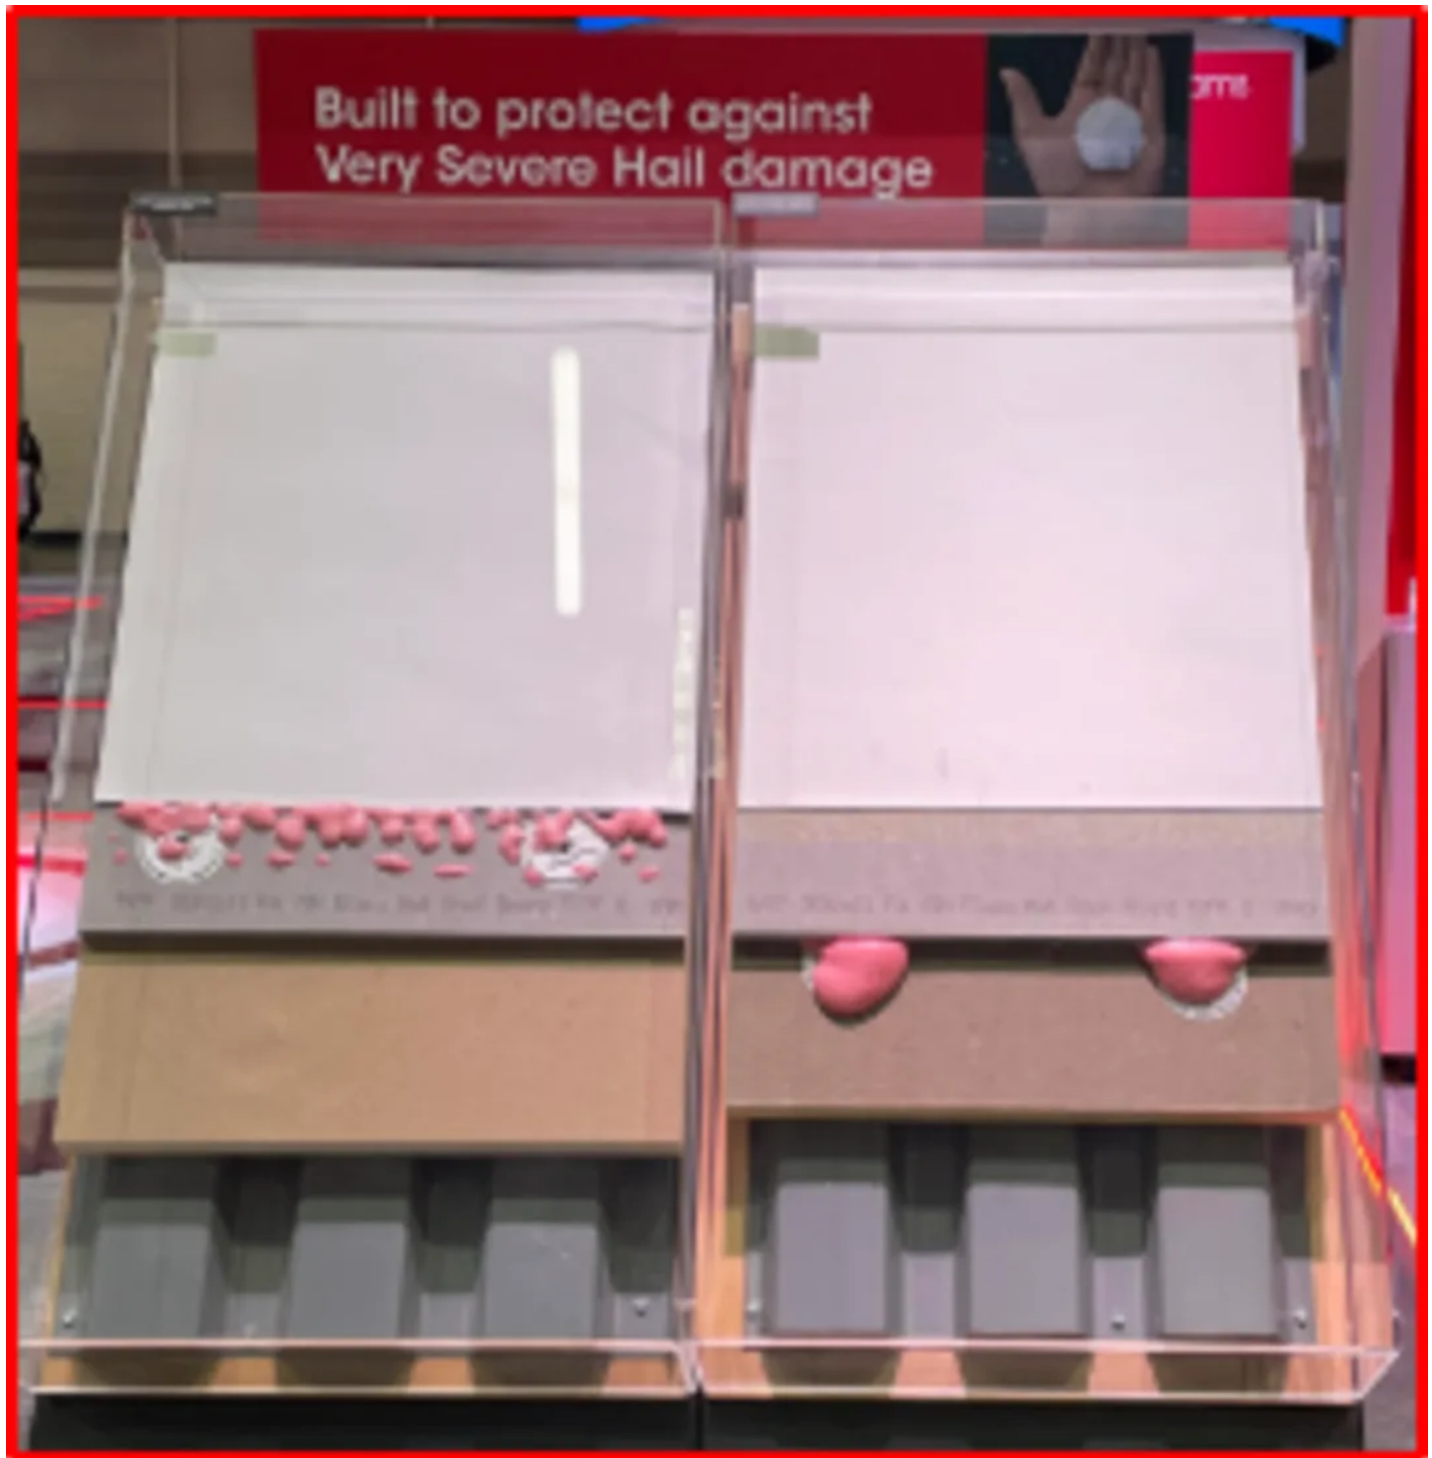
VSH SYSTEMS. LEFT IS SIMULTANEOUSLY FASTENED 60 MIL FLEECEBACK TPO OVER GLASS MAT VSH ROOF BOARD AND POLYISO INSULATION. RIGHT IS 60 MIL FLEECEBACK TPO OVER GLASS MAT VSH ROOF BOARD ADHERED IN LOW RISE FOAM RIBBONS TO MECHANICALLY ATTACHED POLYISO INSULATION.

When VSH assemblies (i.e., those that are designed to withstand the impact of 2" min. hail) first came to market in 2018, there were 44 approved assemblies. Innovative approaches have increased the offerings to more than 16,500, enhancing performance and expanding designers' capabilities, including adhered and mechanically attached systems, which provides flexibility to address weather
